magicolor[®] 330

Service Manual

November 2000
1750049-001B

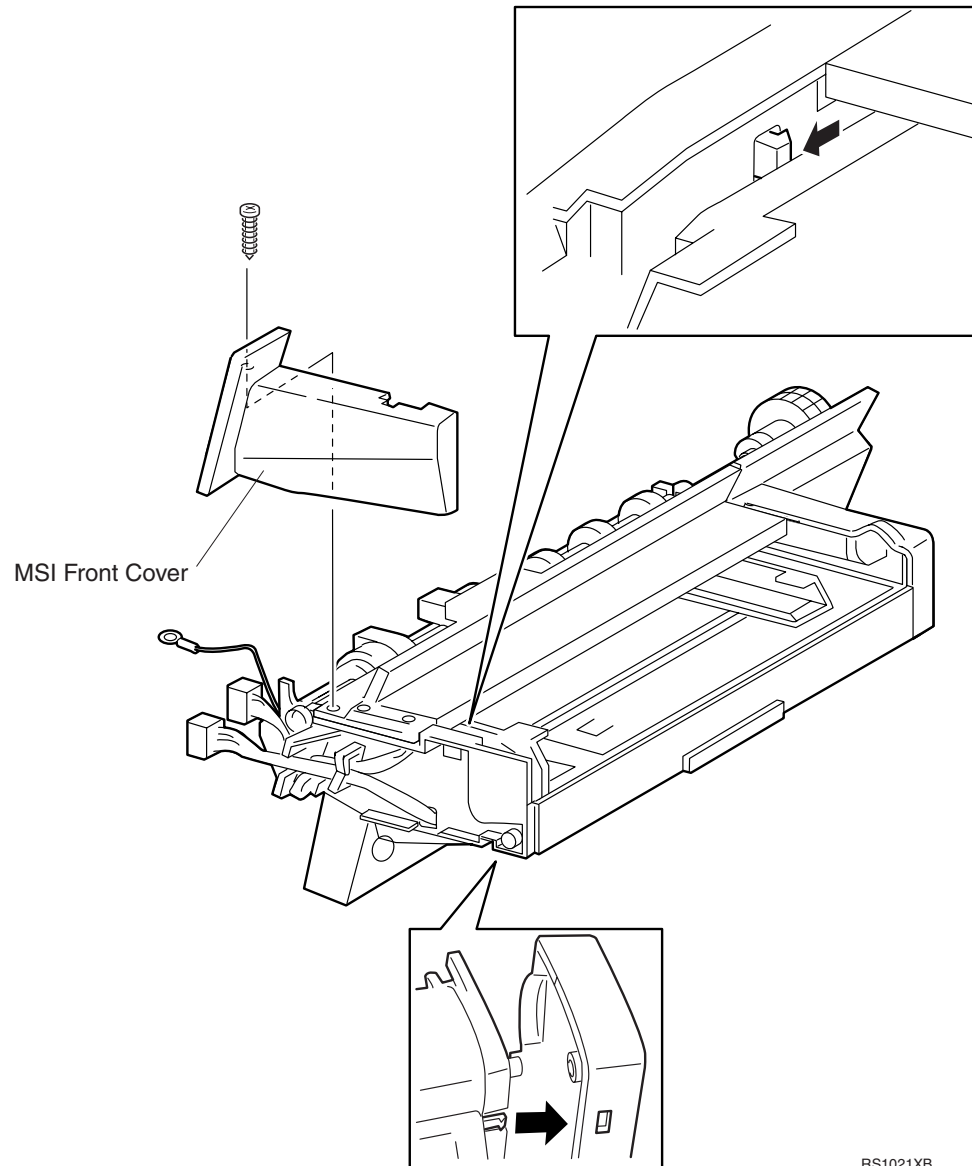
RRP 9.23 MSI Front Cover (PL4.1.3)

1. Position the MSI Front Cover next to the MSI Frame.
2. Hook the latch that is located on the inside of the Cover, under the top lip of the MSI Frame.
3. Push the Cover onto the Frame, making sure the wire harnesses and the ground strap fit through the cutouts in the Cover.
The Cover latch locks into place.
4. Use a screw to secure the top of the MSI Front Cover to the MSI Frame.
5. Reinstall the MSI Assembly (RRP 9.22).

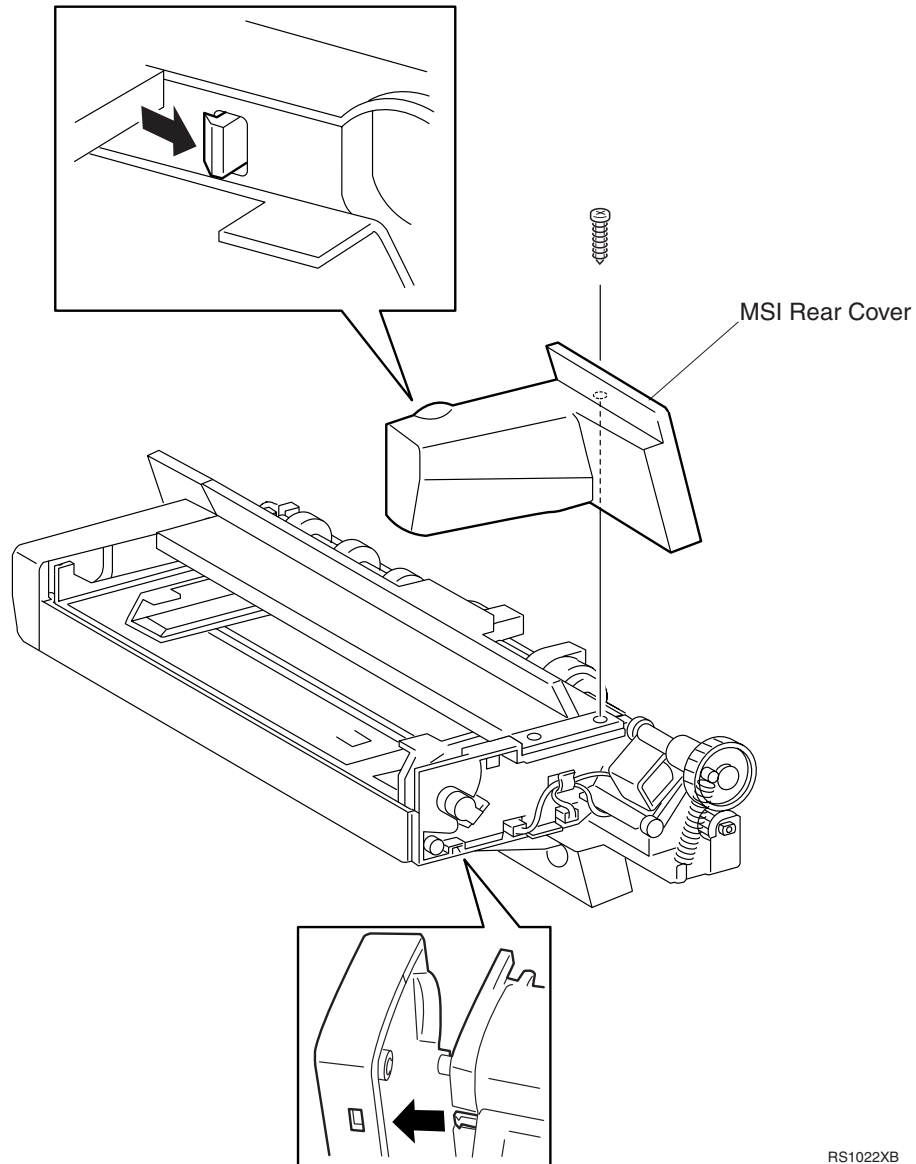
RRP 9.24 MSI Rear Cover (PL4.1.4)

1. Position the MSI Rear Cover next to the MSI Frame.
2. Hook the latch that is located on the inside of the Cover, under the top lip of the MSI Frame.
3. Push the Cover onto the Frame.
The Cover latch locks into place.
4. Use one screw to secure the top of the MSI Rear Cover to the MSI Frame.
5. Reinstall the MSI Assembly (RRP 9.22).

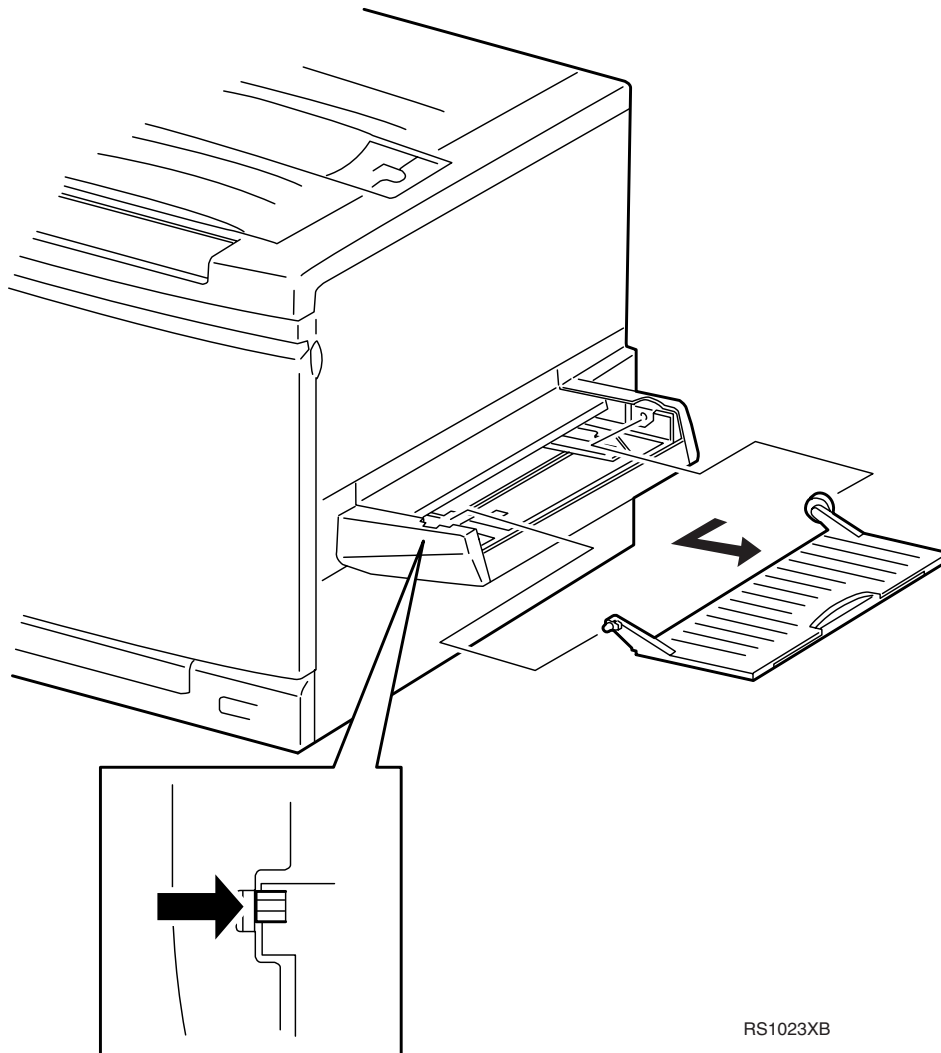
RRP 9.25 MSI Tray Assembly (PL4.1.10)

1. Position the MSI Tray so it is at approximately 90° to the MSI Assembly.
2. Insert the rear arm (gear arm) of the MSI Tray into the rear of the MSI Frame.
3. Press in on the front arm of the MSI Tray as you insert the front arm into the front of the MSI Frame.
4. Move the Tray up and down to make sure it moves smoothly.

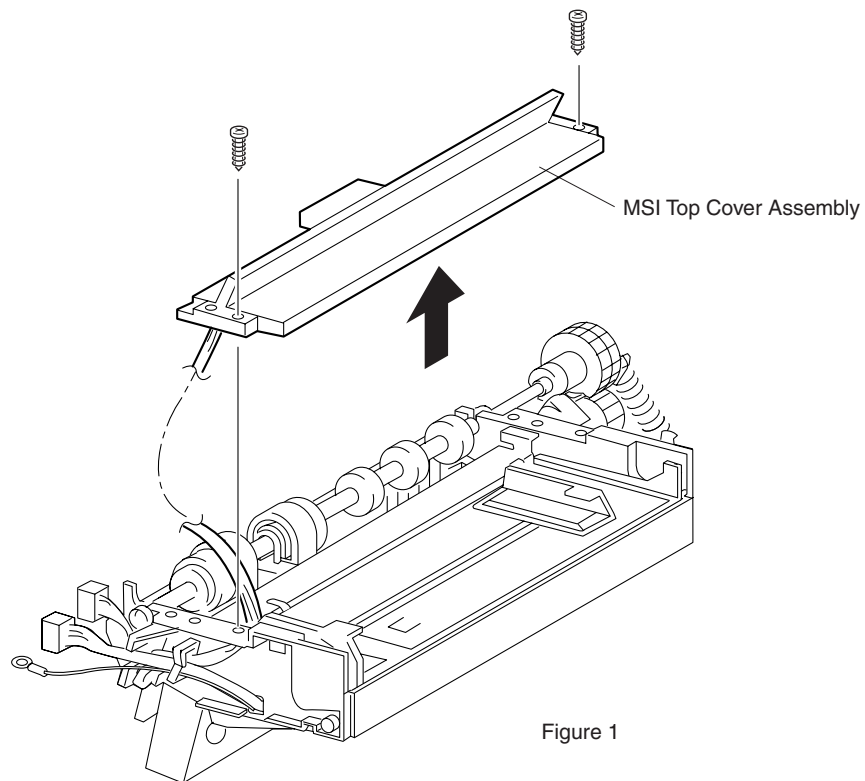
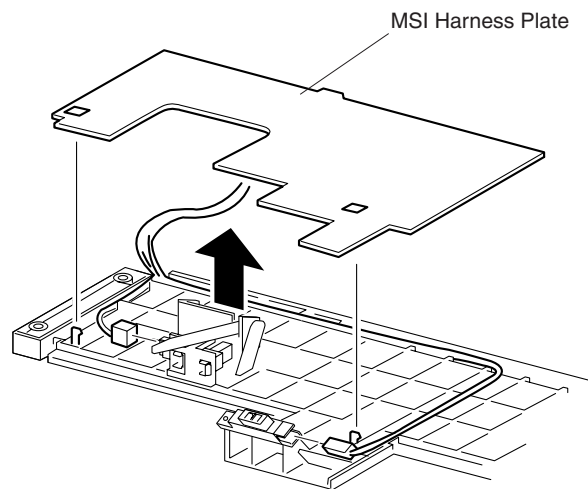
RRP 9.26 MSI Top Cover Assembly (PL4.2.4)

1. Reconnect the P/J's to the two Sensors that are attached to the MSI Top Cover Assembly.
2. Route the wire harnesses along the channels molded into the underside of the Cover.
3. Reinstall the MSI Harness Plate to the MSI Top Cover making sure the two latches secure the Plate to the Cover.
4. Reinstall the MSI Top Cover Assembly to the MSI Frame and use two screws to secure the Cover to the Frame.
5. Reinstall the MSI Rear Cover (RRP 9.24).
6. Reinstall the MSI Front Cover (RRP 9.23).

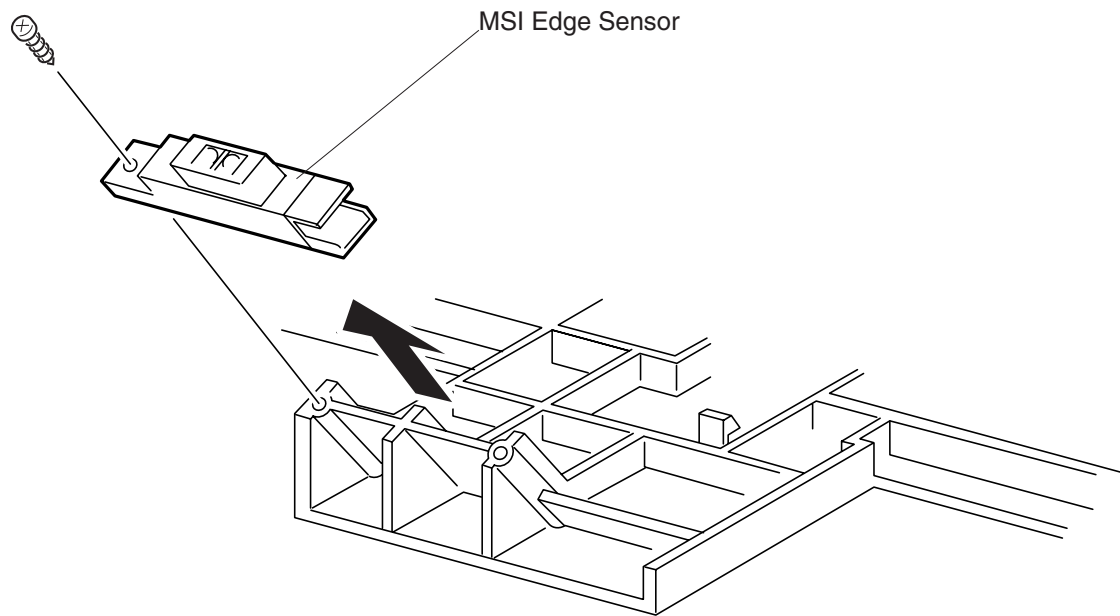
RRP 9.27 MSI Edge Sensor (PL4.2.6)

1. Reinstall the MSI Edge Sensor onto the MSI Top Cover Assembly, making sure the positioning tab on the bottom of the Sensor fits into the hole in the Top Cover Assembly.
2. Use one screw to secure the MSI Edge Sensor to the MSI Top Cover Assembly.
3. Reinstall the MSI Top Cover Assembly (RRP 9.26).

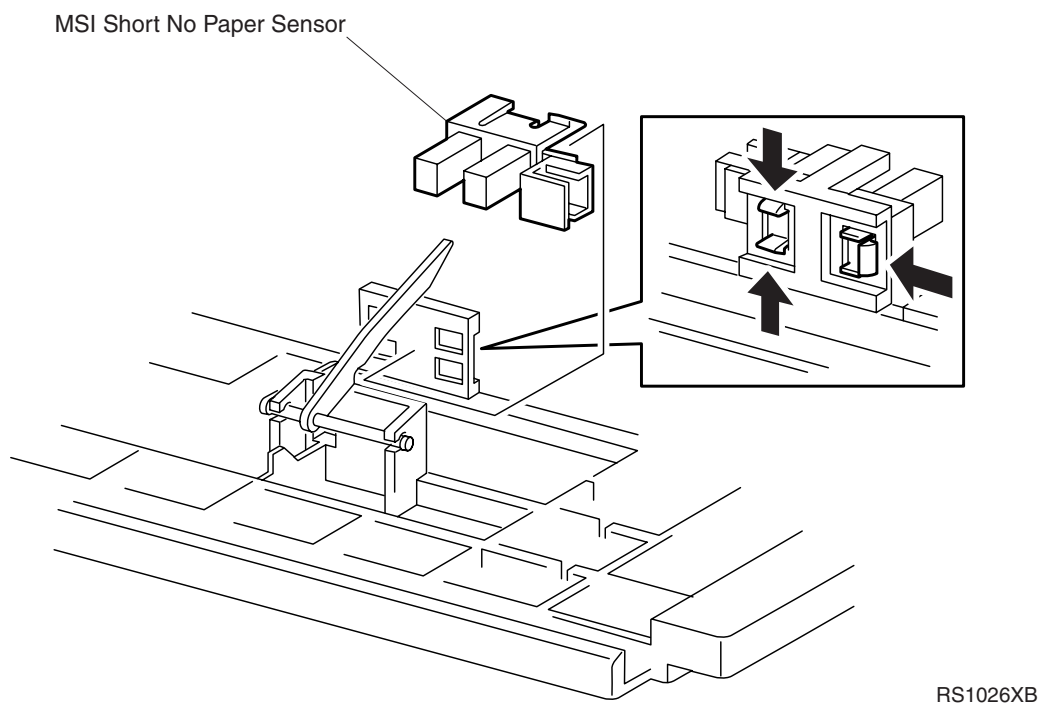
RRP 9.28 MSI Short No Paper Sensor (PL4.2.7)

1. Reinstall the MSI Short No Paper Sensor onto the MSI Top Cover Assembly.
2. Press the Sensor latches into the cutouts in the Cover.
The Sensor snaps into place.
3. Reinstall the MSI Top Cover Assembly (RRP 9.26).

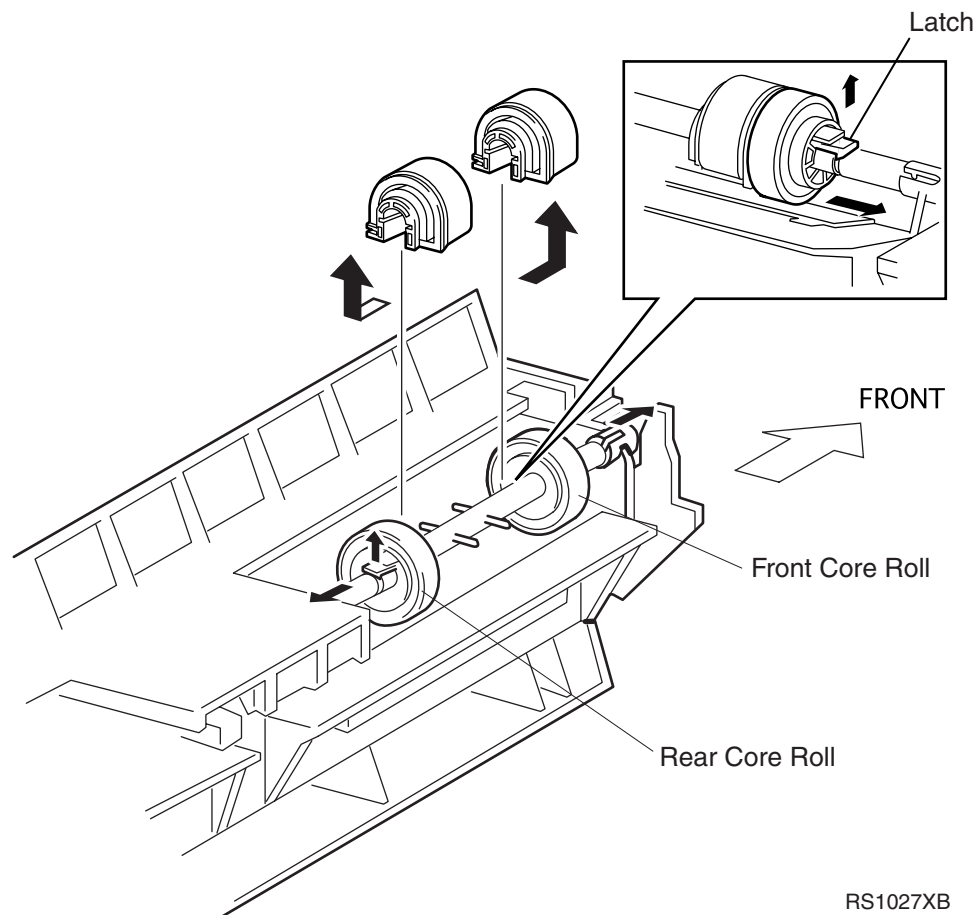
RRP 9.29 MSI Pick Up Roll (PL4.2.11)

We recommend that you replace Pick Up Rolls as a set.

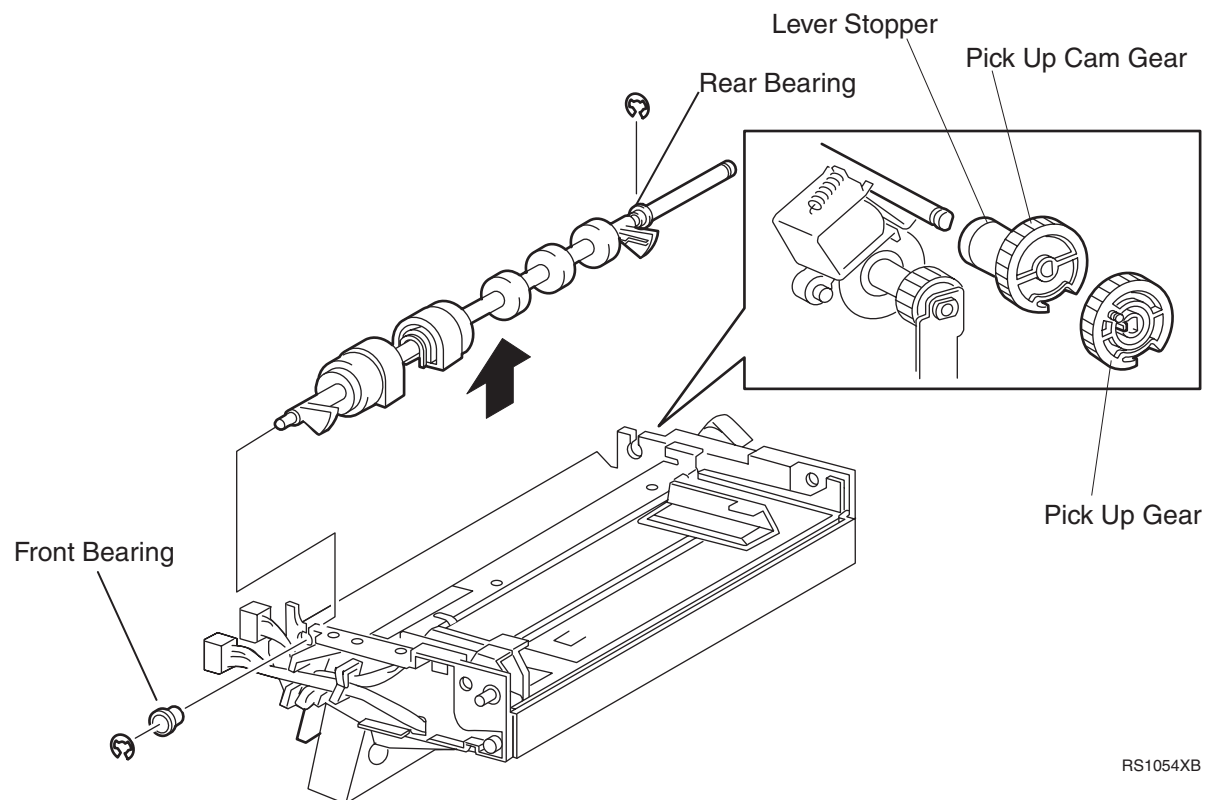
RRP 9.30 MSI Roll Assembly (PL4.2.9)

1. Reinstall the MSI Roll Assembly by sliding the front and rear of the Shaft into the front and rear cutouts in the MSI.
2. Slide the front shaft bearing into the front bearing cutout and use an E ring to secure the bearing.
3. Slide the rear shaft bearing into the rear bearing cutout and use an E ring to secure the bearing.
4. Push down the arm of the Pick Up Solenoid as you slide the Lever Stopper, Pick Up Cam Gear, and Pick Up Gear onto the Shaft.
The Pick Up Gear latches lock the Gears in place on the Shaft.
5. Hook the Pick Up Spring onto the Pick Up Gear.
6. Reinstall the MSI Top Cover Assembly (RRP 9.26).

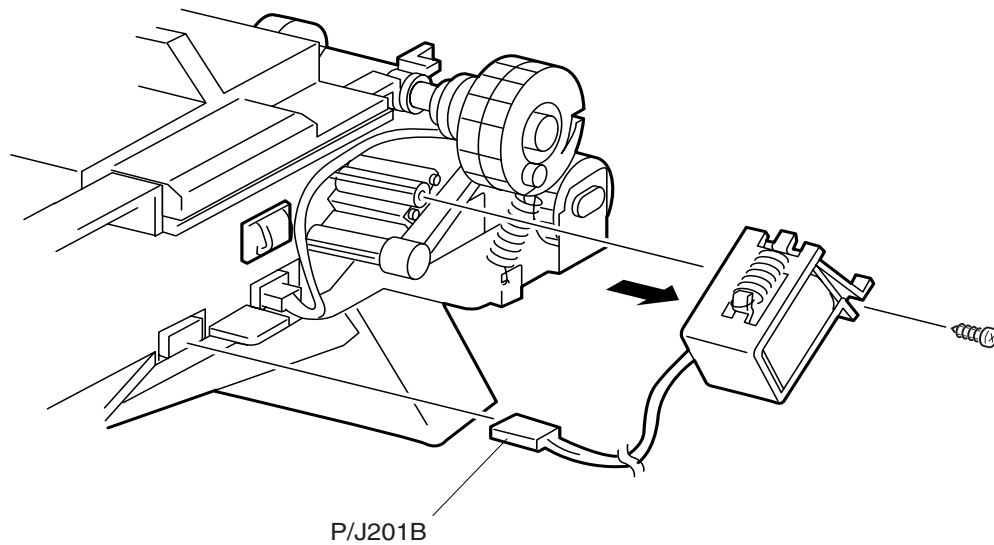
RRP 9.31 MSI Pick Up Solenoid (PL4.2.21)

1. Remove the MSI Rear Cover (RRP 9.24).
2. Hold down the MSI Pick Up Solenoid arm as you reinstall the Solenoid against the MSI frame.
3. Reposition the Solenoid so the two locating pins on the Frame line up with the two holes in the Solenoid.
4. Use one screw to secure the MSI Pick Up Solenoid to the MSI Frame.
5. Reconnect P/J 201B.
6. Reinstall the MSI Rear Cover (RRP 9.24).

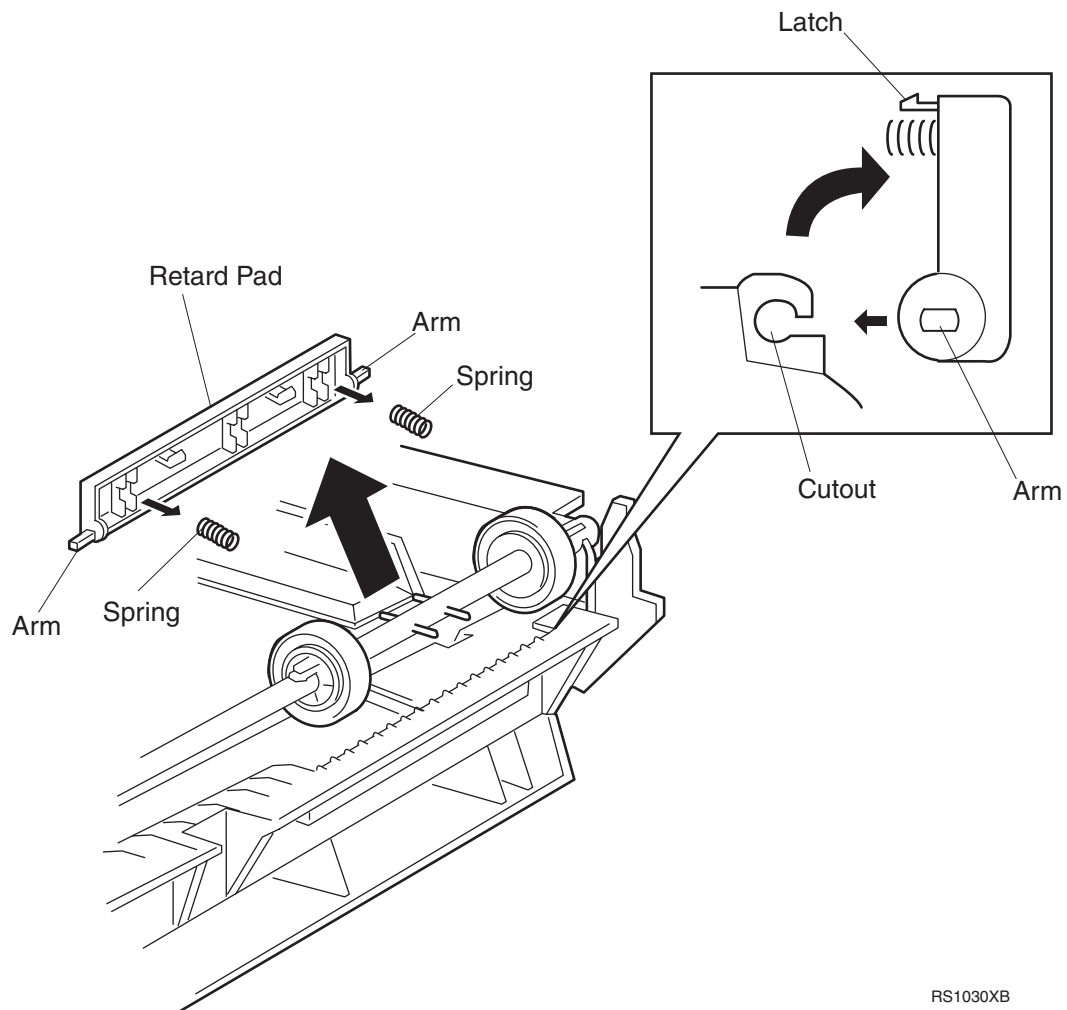
RRP 9.33 MSI Retard Pad Assembly (PL4.3.3)

1. Position the MSI Retard Pad Assembly so the arms are at the bottom and the springs are facing the MSI Frame.
2. Push the MSI Bottom Plate out of the way.
3. Slide the two arms of the MSI Retard Pad Assembly into the two cutouts in the MSI Frame.
4. Push the MSI Retard Pad Assembly against the MSI Frame until the two Retard Pad latches snap into place.
5. Press and release the Retard Pad to make sure it moves smoothly and has a slight spring action return.
6. Reinstall the MSI Pick Up Rolls (RRP 9.29).

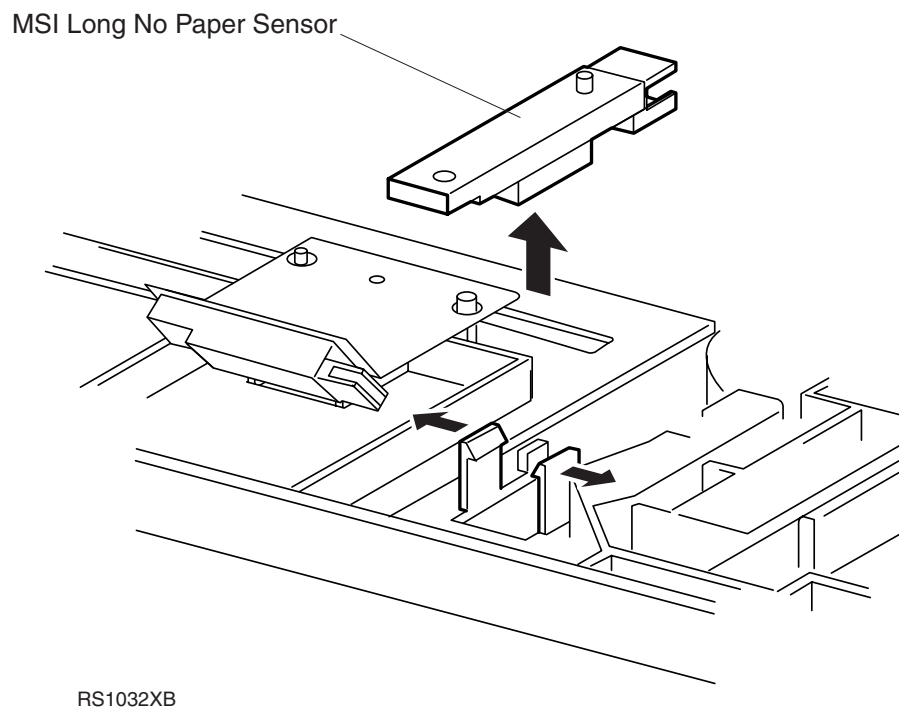
RRP 9.35 MSI Long No Paper Sensor (PL4.3.16)

1. Position the MSI Long No Paper Sensor onto the MSI Bottom Assembly so the position tab on the Assembly fits through the positioning hole at the end of the Sensor.
2. Spread the latches and press the Sensor onto the MSI Bottom Assembly.
The latches lock the Sensor into place.
3. Reinstall the MSI Bottom Assembly (RRP 9.34).

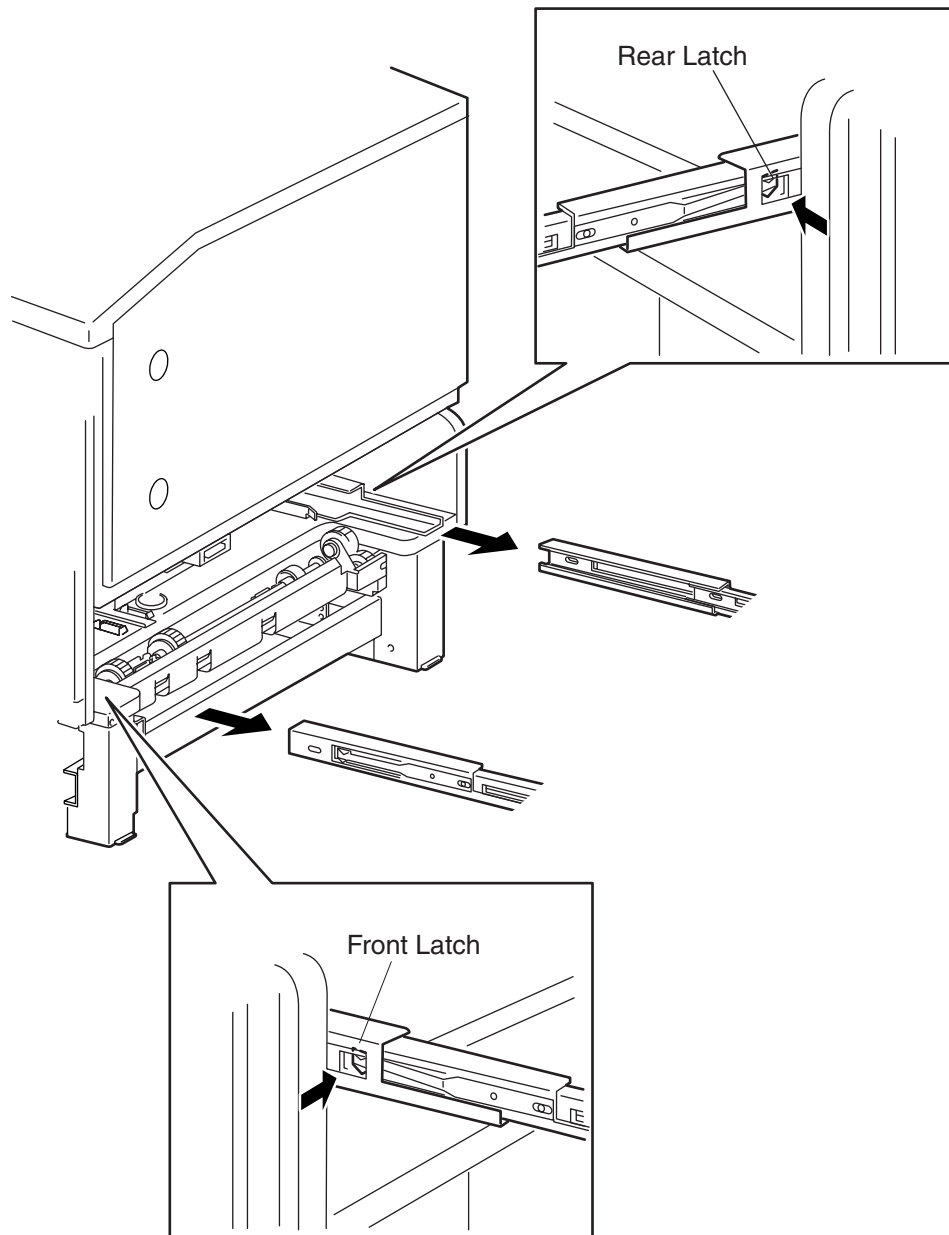
RRP 9.36 Main Paper Handling Assembly (PL5.1.1)

1. Position the Main Paper Handling Assembly so the Front and Rear Rails on the Assembly line up with the Front and Rear Rails of the printer frame.
2. Push in on the Rear Rail latch as you slide the rear of the Assembly into the printer far enough so the latch engages.
3. Push in on the Front Rail latch as you slide the rear of the Assembly into the printer far enough so the latch engages.
4. Slide the Main Paper Handling Assembly all the way into the printer and then out again to make sure the Assembly slides smoothly.
5. Reinstall the MSI Assembly (RRP 9.22).

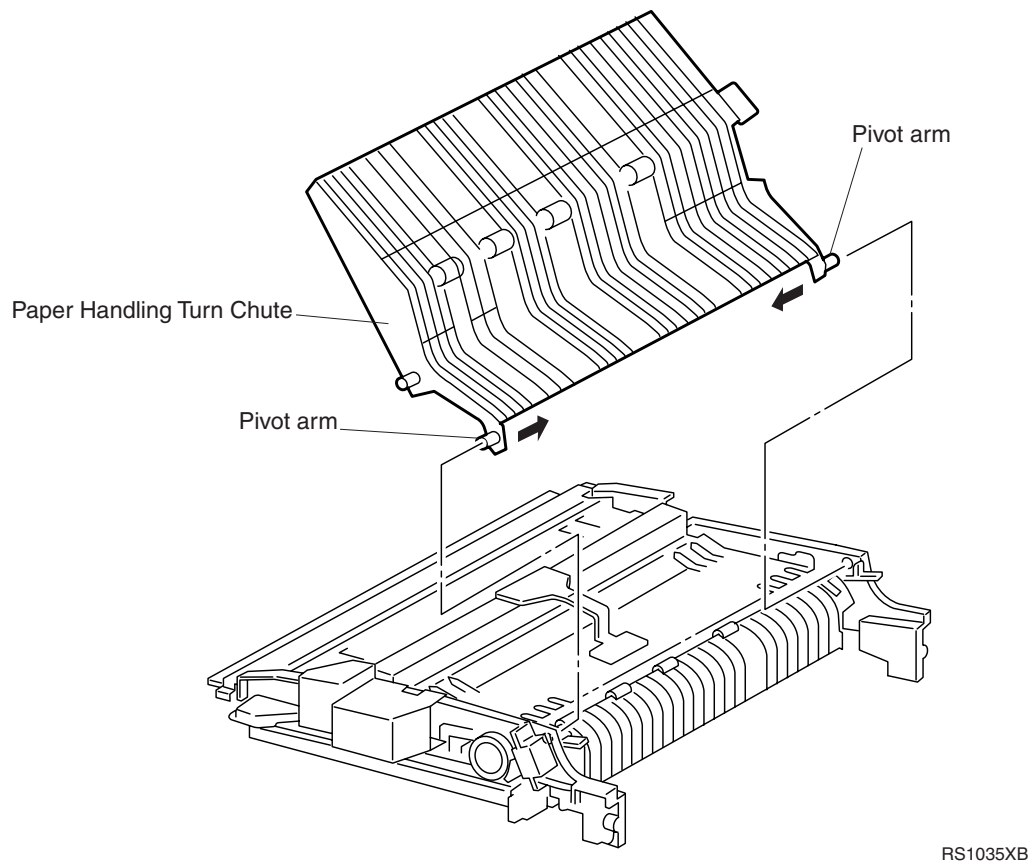
RRP 9.37 Paper Handling Turn Chute Assembly (PL5.1.4)

1. Insert the front and rear pivot arms located at the top of the Paper Handling Turn Chute Assembly into the holes at the top of the Main Paper Handling Assembly.
2. Swing the Paper Handling Turn Chute Assembly down into position and insert the front and rear pivot arms located at the bottom of the Paper Handling Turn Chute Assembly into the holes at the bottom of the Main Paper Handling Assembly.
3. Reinstall the Pre-Registration Chute Assembly (RRP 9.38).
4. Reinstall the Main Paper Handling Cover onto the Main Paper Handling Assembly and use two screws to secure the Cover to the Assembly.
5. Reinstall the MSI Assembly (RRP 9.22).

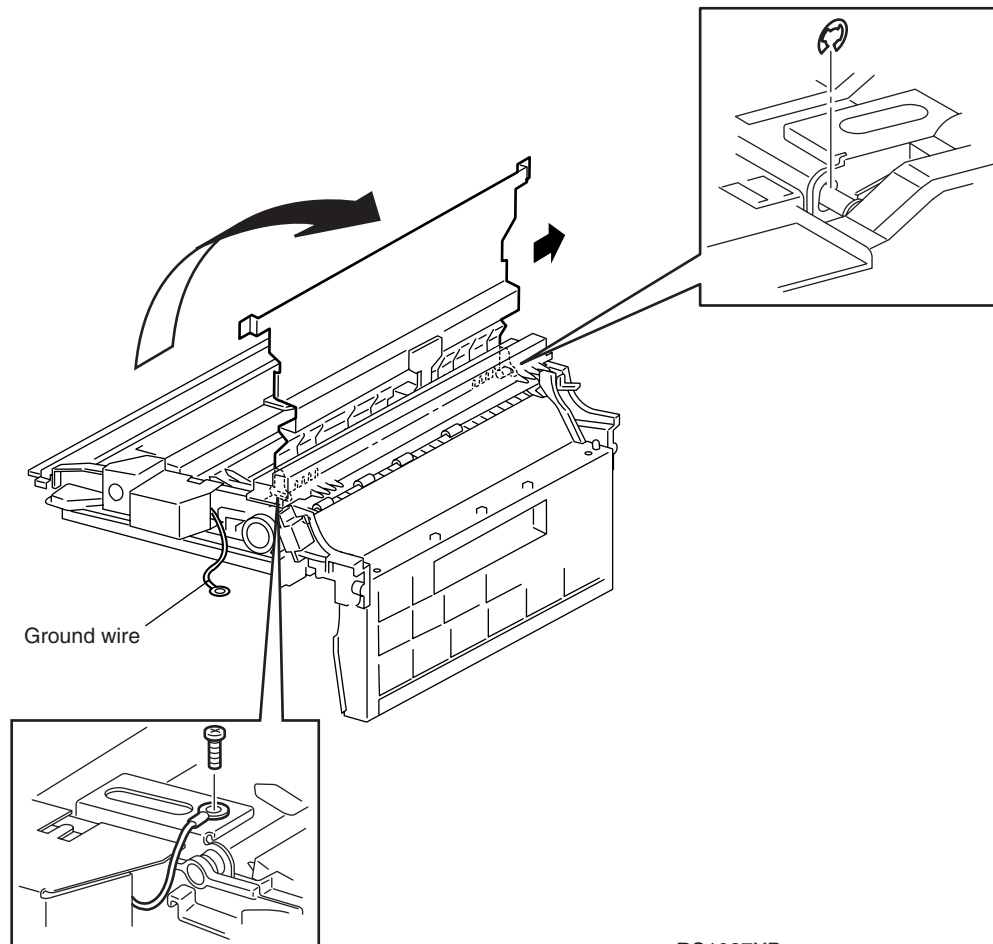
RRP 9.39 Registration Chute Assembly (PL5.1.6)

1. Slide the Main Paper Handling Assembly out of the printer.
2. Slide the rear arm of the Registration Chute Assembly onto the metal pivot that is located at the rear of the Main Paper Handling Assembly.
3. Slide the rear arm far enough onto the rear arm so you can slide the front arm onto the front metal pivot.
4. Slide the Registration Chute Assembly forward so the E ring channel on the rear pivot is behind the rear arm.
5. Use an E ring to secure the rear arm of the Registration Chute Assembly to the Main Paper Handling Assembly.
6. Reinstall the ground wire to the Assembly and use one screw to secure the wire.
7. Close the Main Paper Handling Assembly.

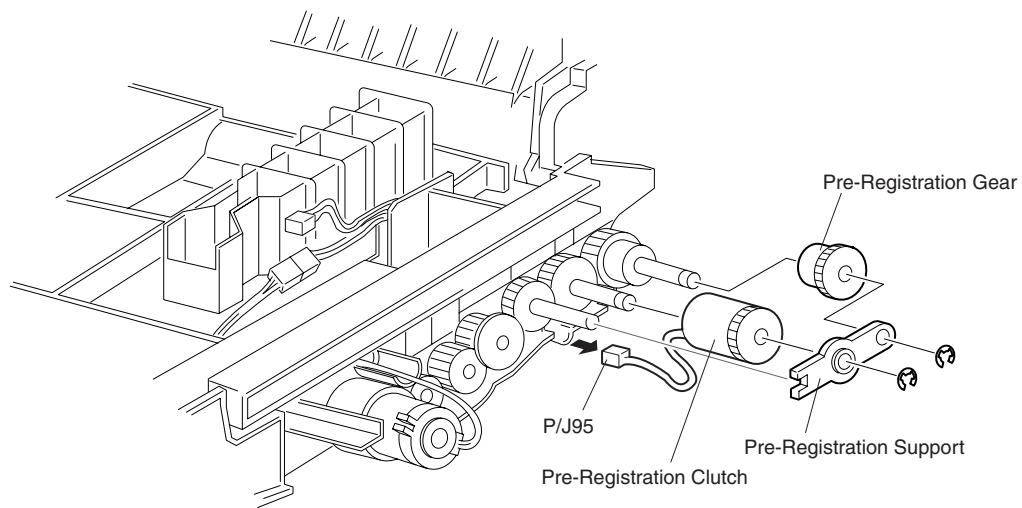
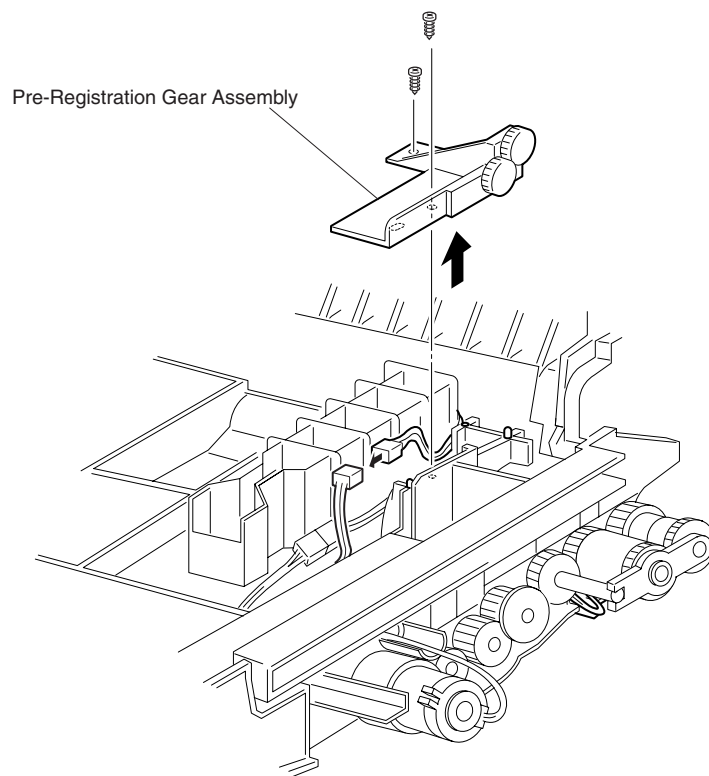
RRP 9.41 Pre-Registration Clutch (PL5.2.8)

1. Slide the Pre-Registration Clutch onto the Shaft, making sure you slide the key of the Clutch into the tab on the Main Paper Handling Assembly.
2. Slide the Pre-Registration Gear onto the Shaft.
3. Reinstall the Registration Support, making sure you install the open end of the Support onto the Gear 12 shaft.
4. Use E rings to secure the Pre-Registration Clutch and the Pre-Registration Gear to the Pre-Registration Support.
5. Reconnect P/J 95 and route the wire away from any gears.
6. Reinstall the Pre-Registration Gear Assembly to the Main Paper Handling Assembly and use two screws to secure the Gear Assembly.
7. Reinstall the Pre-Registration Chute Assembly (RRP 9.38).
8. Reinstall the Main Paper Handling Assembly (RRP 9.36).

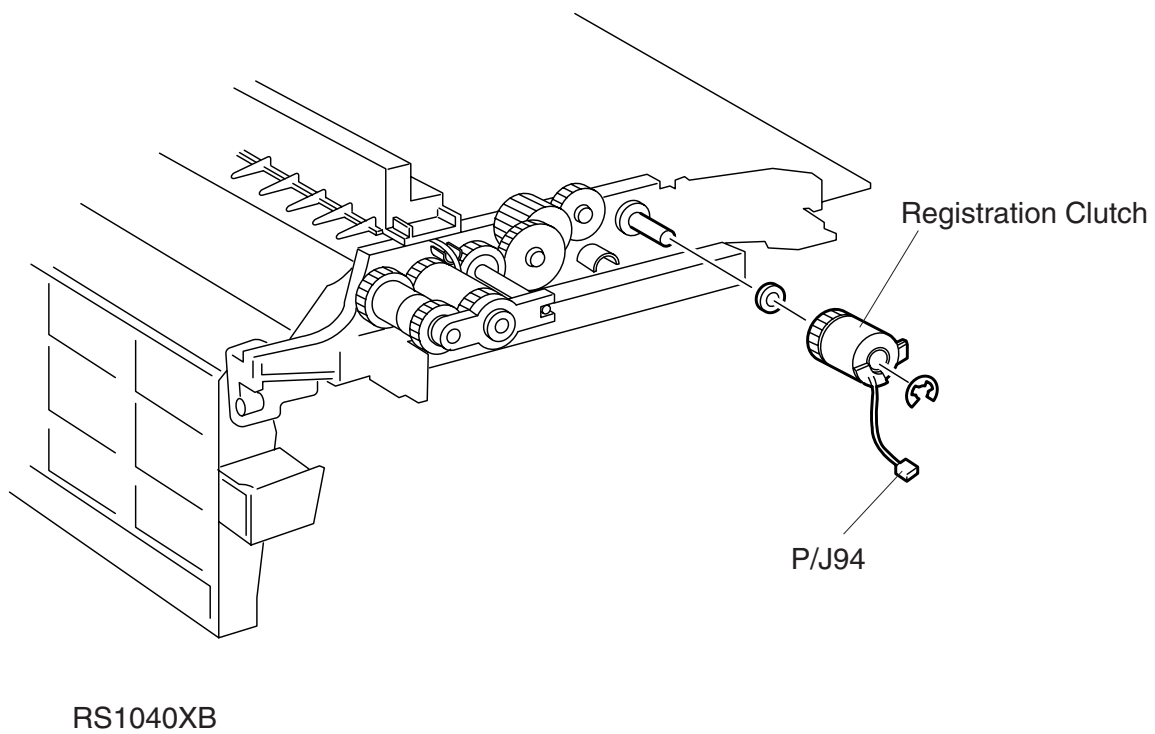
RRP 9.42 Registration Clutch (PL5.2.15)

1. Slide the Registration Clutch onto the end of the Metal Registration Roll making sure you slide the key of the Clutch into the tab on the Main Paper Handling Assembly.
2. Use an E ring to secure the Registration Clutch to the Metal Registration Roll.
3. Route the Registration Clutch wire to the underside of the Main Paper Handling Assembly and reconnect P/J 94.
4. Reinstall the Main Paper Handling Assembly (RRP 9.36).

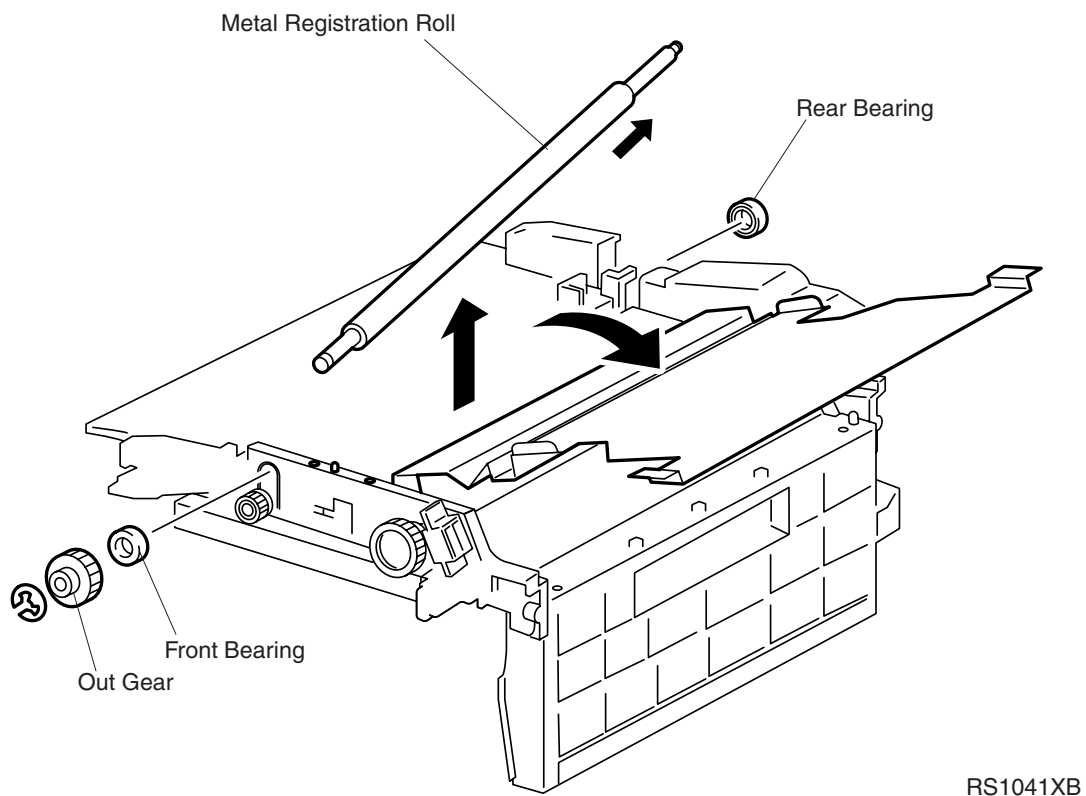
RRP 9.43 Metal Registration Roll (PL5.2.16)

1. Insert the front end of the Metal Registration Roll into the front bearing.
2. Snap the rear of the Metal Registration Roll into the rear bearing notch in the Main Paper Handling Assembly.
3. Slip the rear bearing over the rear end of the Metal Registration Roll and slide the bearing in place in the Main Paper Handling Assembly.
4. Slide the Out Gear onto the front of the Metal Registration Roll and push it against the Main Paper Handling Assembly.
5. Use an E ring to secure the Gear onto the end of the Metal Registration Roll.
6. Reinstall the Registration Brake Clutch (RRP 9.46).
7. Reinstall the Registration Clutch (RRP 9.42).

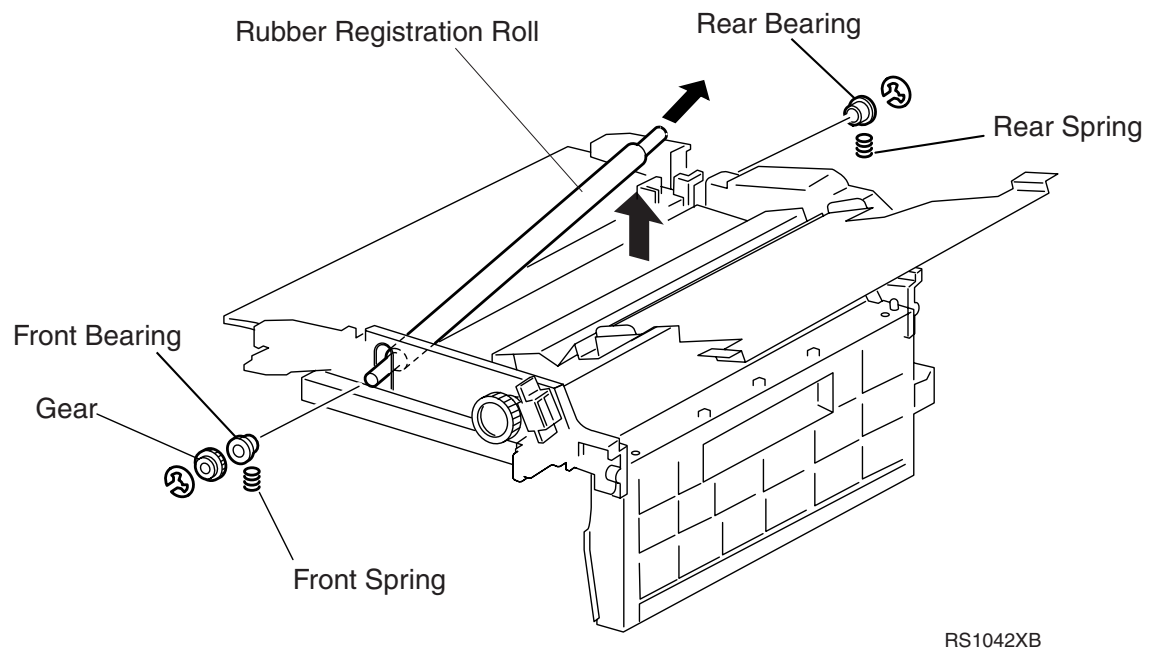
RRP 9.44 Rubber Registration Roll (PL5.2.24)

1. Slide the front end of the Rubber Registration Roll into the front bearing in the Main Paper Handling Assembly.
2. Hold the mylar strip out of the way as you insert the Rubber Registration Roll into the channel in the Main Paper Handling Assembly.
3. Make sure the mylar strip rests on top of the Rubber Registration Roll.
4. Reinstall the rear bearing and Spring, facing down, onto the rear of the Roll.
5. Use an E ring to secure the rear of the Roll to the rear bearing.
6. Reinstall the Gear onto the front end of the Rubber Registration Roll and use an E ring to secure the Gear to the Roll.
7. Reinstall the Metal Registration Roll (RRP 9.43).

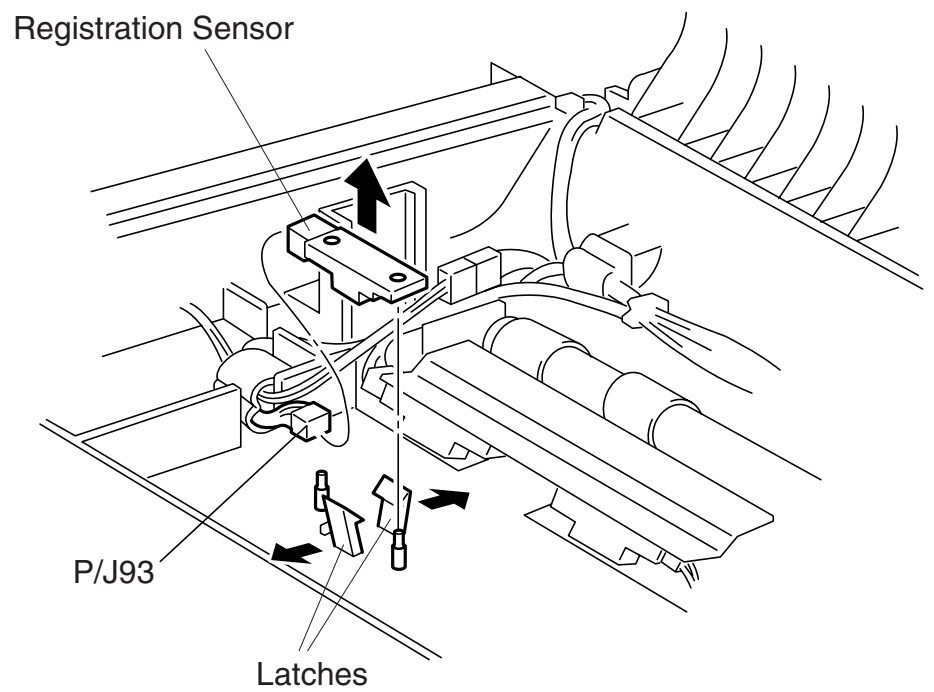
RRP 9.45 Registration Sensor (PL5.2.28)

1. Align the Registration Sensor so the LEDs are against the Main Paper Handling Assembly and the positioning hole at the end of the Sensor is over the positioning tab on the Assembly.
2. Carefully press the Registration Sensor into position on the Main Paper Handling Assembly.
The latch arms lock the Sensor into place.
3. Reconnect P/J 93 to the Registration Sensor.
4. Reinstall the Main Paper Handling Assembly (RRP 9.36).

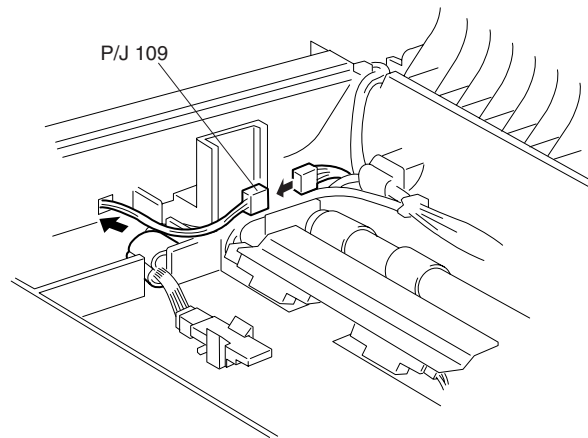
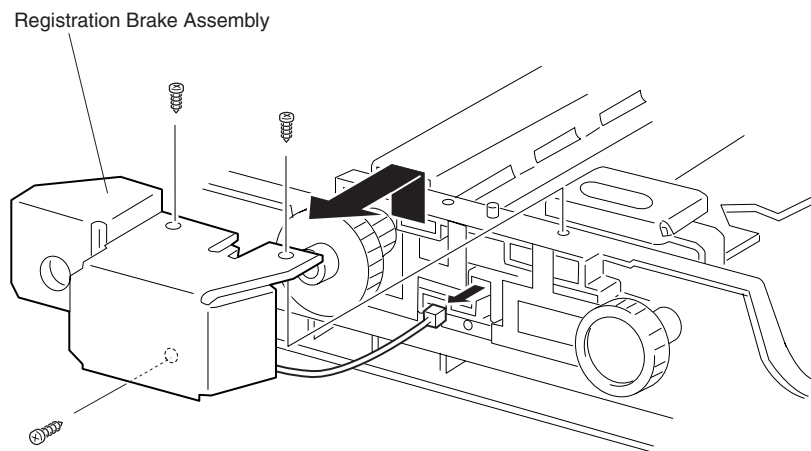
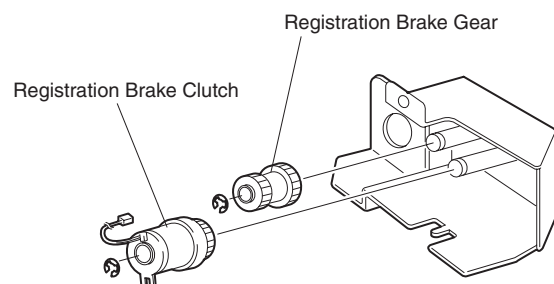
RRP 9.46 Registration Brake Clutch (PL5.2.20)

1. Reinstall the Registration Brake Gear onto the Gear shaft and use an E ring to secure the Gear (Figure 3).
2. Reinstall the Registration Brake Clutch onto the Clutch shaft and use an E ring to secure the Clutch.
3. Reinstall the Registration Brake Clutch Assembly onto the side of the Main Paper Handling Assembly making sure you thread the Clutch wire harness through the hole in the side of the Paper Handling Assembly.
4. Use three screws to secure the Registration Brake Clutch Assembly to the Main Paper Handling Assembly.
5. Reconnect P/J 109 to the Registration Brake Clutch (Figure 1).
6. Reinstall the Main Paper Handling Assembly (RRP 9.36).

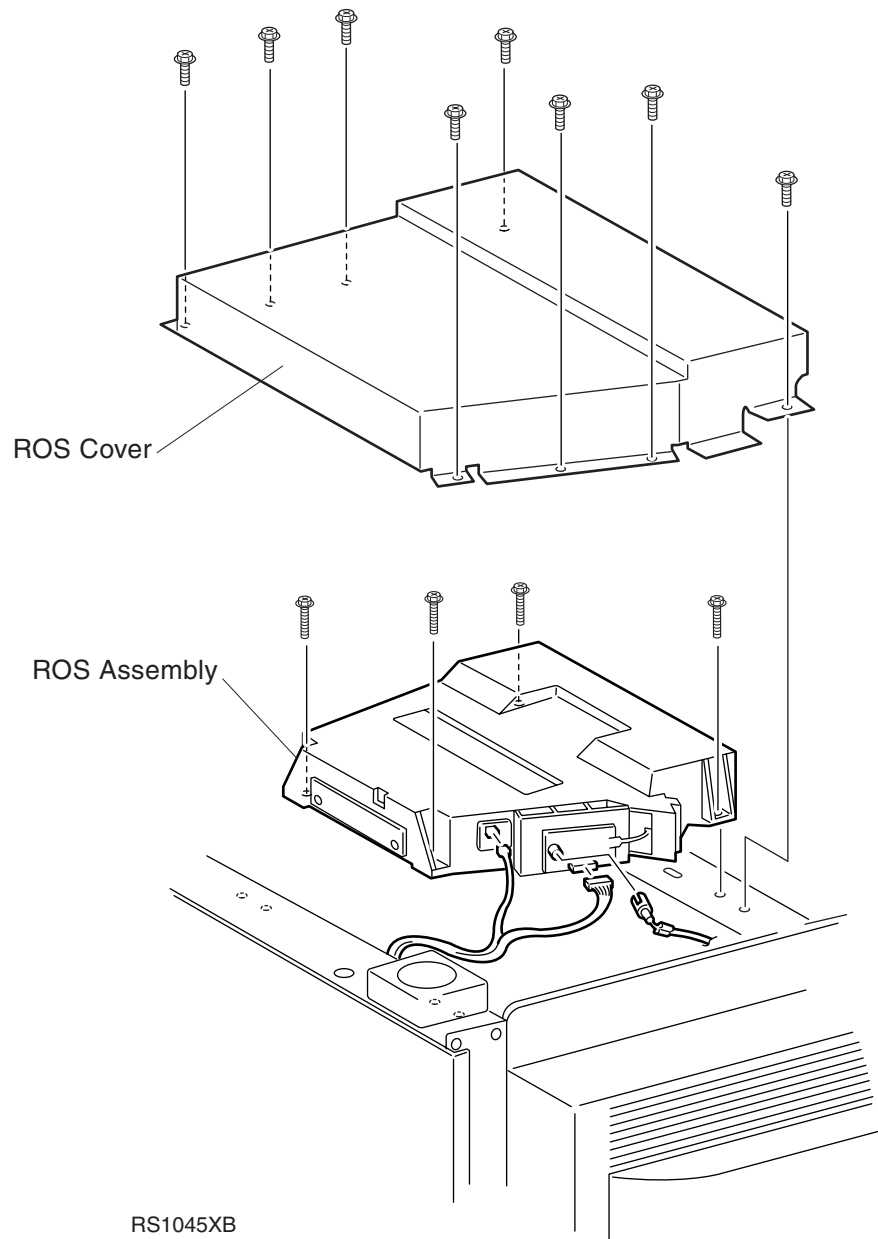
RRP 9.47 ROS Assembly (PL6.1.1)

1. Position the ROS Assembly over the printer frame.
2. Reconnect P/J 123 to the ROS Motor PWB located under the Assembly.
3. Lower the ROS Assembly onto the printer frame and line up the four screws holes in the Assembly with the four screw holes in the frame.
4. Use four screws to secure the ROS Assembly to the printer frame.
5. Reconnect P/J 124 to the SOS Sensor PWB.
6. Reconnect P/J 121 and P/J 122 to the Laser Diode PWB.
7. Reinstall the ROS Cover over the ROS Assembly and use eight screws to secure the Cover to the printer frame.
8. Reinstall the Top Cover Assembly (RRP 9.3).

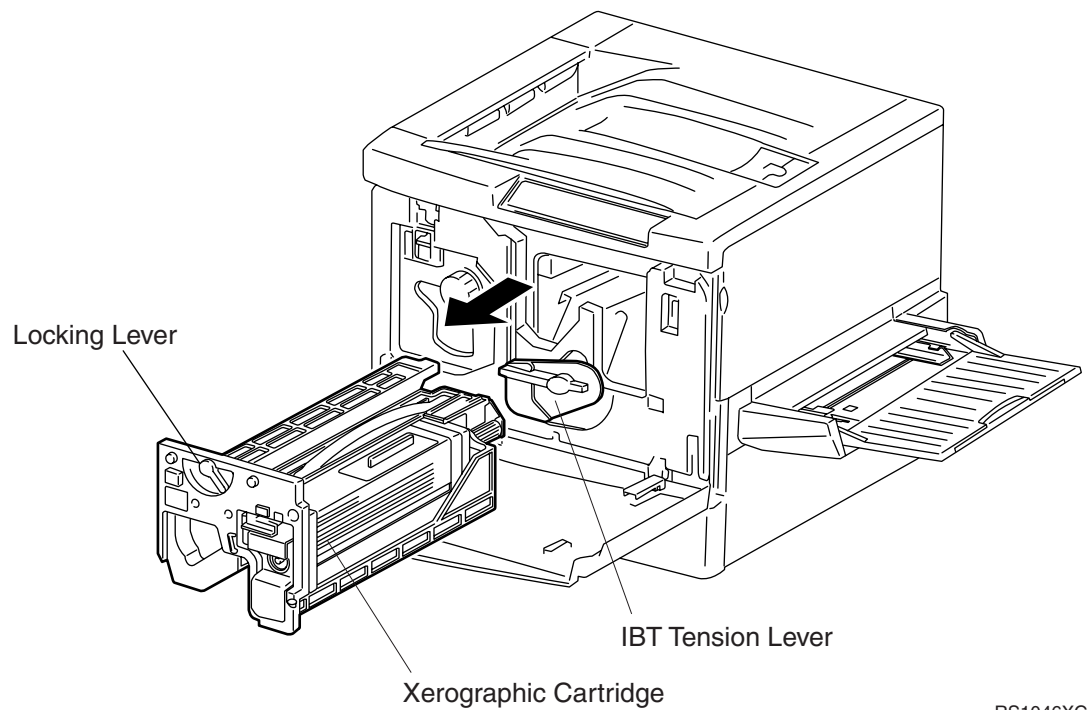
RRP 9.48 Xerographic Cartridge (PL6.1.11)

1. Open the Front Cover.
2. Lower the IBT Tension Lever.
3. Move the Xerographic Cartridge locking lever to the right.
4. Pull the Xerographic Cartridge approximately eight inches out of the print engine.
5. Use one hand to hold onto the Cartridge strap and use the other hand to pull the Cartridge free of the print engine.
6. Place the Xerographic Cartridge in a light-tight bag to protect the Xerographic Drum from light damage.

The Xerographic Drum, the large blue cylinder, is easily damaged. Use extreme care when removing or storing the Cartridge so it does not get scratched or nicked.

1. Open the Front Cover.
2. Lower the IBT Tension Lever.
3. Move the Xerographic Cartridge locking lever to the right.
4. Use one hand to hold onto the Cartridge strap and use the other hand to push the Cartridge into the print engine cavity.
5. Line up the rail at the top left of the Cartridge with the rail in the print engine cavity.
6. Keep the Cartridge level as you carefully push the Cartridge into the cavity.
7. When the Cartridge is completely inside the cavity, move the locking lever to the left to lock the Cartridge in place.
8. Pull out on the Cartridge to make sure it is secured in place.
9. Raise the IBT Tension Lever.
10. Close the Front Cover.
11. If your printer configuration does not support the CRUM automatic life counter reset, then refer to Section 9 of this manual and reset the Xerographic Cartridge Life Counter to zero.
